SEWER MASTER PLAN

Village of Lytton

March 18, 2022

Dan Mundall, P.Eng.

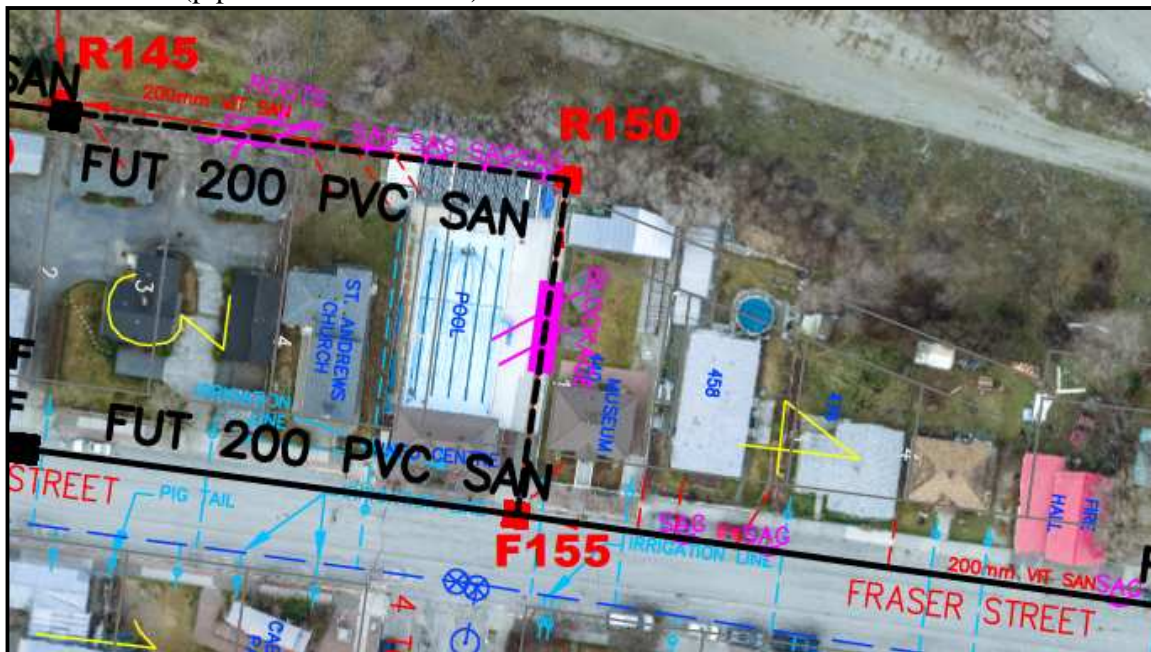
Individual videos were annotated in the field with voice and text describing the reach and any other particulars. Still frames were grabbed for problem areas for future reference. Following the video inspections the videos were further reviewed and relevant information was cataloged in an excel spreadsheet and also placed in AutoCAD for geographical reference. The photomap drawing excerpt below illustrates the resulting visual reference – symbols were created and referenced for:

- Roots (usually intrusion at pipe joints)
- Sag (depression section causing stagnant reach where pipe flow is abnormally slow)
- Blockage (rock or other obstruction)
- Defect (pipe construction issue)

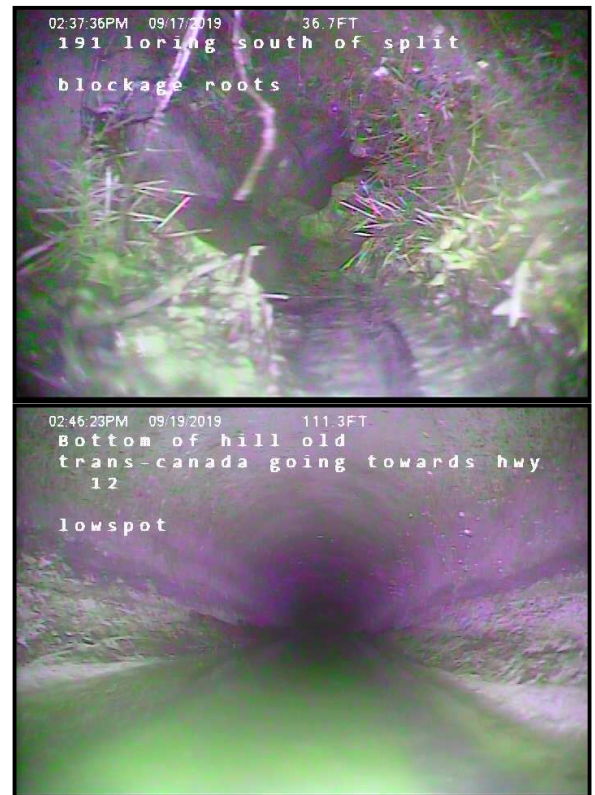
- Many of the clay and A/C sewer pipes have root intrusion at the joints. This can be remedied by upgrading the sewer with slip-lining or pipe bursting technologies but is not recommended for most areas because the size, slope or depth of the existing sewers are also inadequate .

- Clay/AC sewers with inadequate slope and sagging sections that have ponding are accumulating solids on key sewers in the Village. The sagging may be caused by ground subsidence or construction irregularity but these sections cause solids to build up and result in clogged sewers that frequently require scour and purge with municipal hydro-vac equipment.

- There is inadequate depth in some areas to allow adequate slope.
- Inadequate size – 150mm sewers are easily plugged and are inadequate for critical trunk flow. It is recommended to replace these with 200mm PVC as a minimum for sewer mains and 250mm PVC or even 300mm PVC for trunk sections.

- Infiltration/exfiltration potential exists with all clay sewers but according to plant operators infiltration has not been a problem and has never increased flow above licensed treatment capacity. It is likely this is due to the low water table in the Village and the prevalence of gravelly well drained soils. Exfiltration (leakage) is more likely and the impact on nearby wells should be considered in replacement efforts. This is one reason for replacement of sewer piping along Alonzo Way where the Village has an active water supply well.

Figures 3-A1 and 3-A2 (attached drawings both with and without photomap) show the Village sewer collection network and highlight observed problems and sections that are recommended for replacement in the next 10 years.

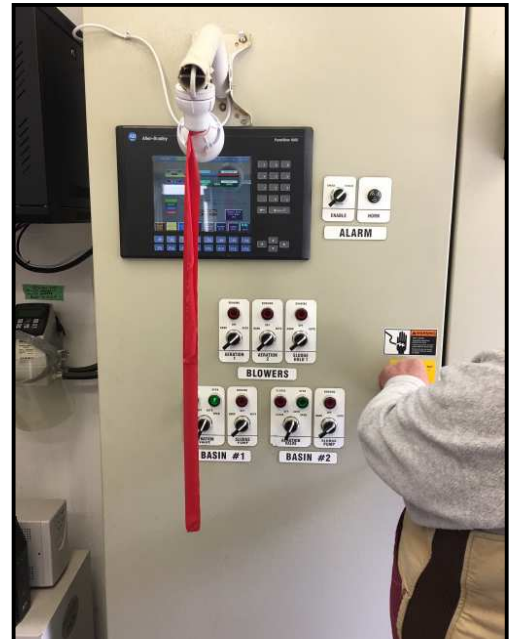
- **PLC Control Cabinet and HMI Interface (photo →)**

Upgrades are underway on PLC integration to SCADA. An interim operator workaround network video camera on interface panel with red ribbon so operators don't bang their heads.
