PROJECT STATUS REPORT

To:	Village of Lytton	Contact:	CAO – Michael Baker
Project:	Lytton Recovery	From:	Recovery Project Manager - James Heigh
Report Period:	September 2022	Date Issued:	Oct 11, 2022

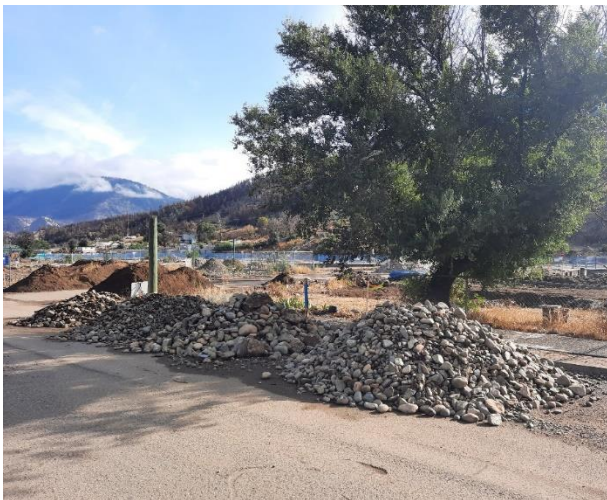
Figure 5 – Separated piles

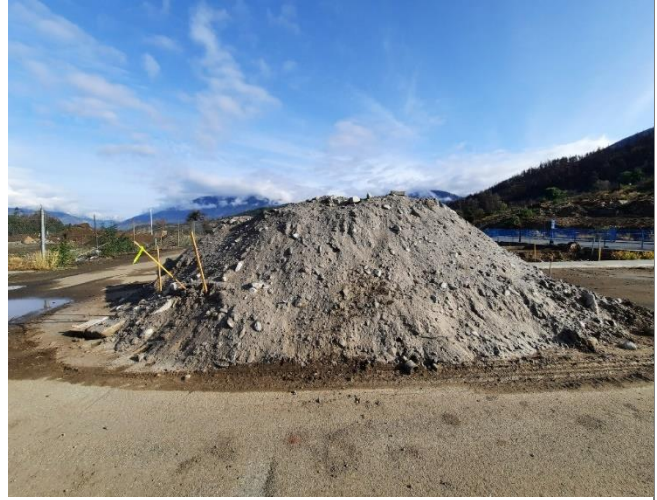
Matcon has begun stabilizing hazardous waste soils and debris by the addition of Portland Cement at the following properties:

- 84 Main Street
- 58 Main Street
- 341 Fraser Street

Figure 6 – Portland Cement stabilization of contaminated soils

IBI is in the process of collecting post treatment samples following implementation of Matcon's stabilization process to determine the efficacy of the stabilization program. These samples are analyzed for leachable metals (based on TCLP analysis) to determine subsequent waste classification.

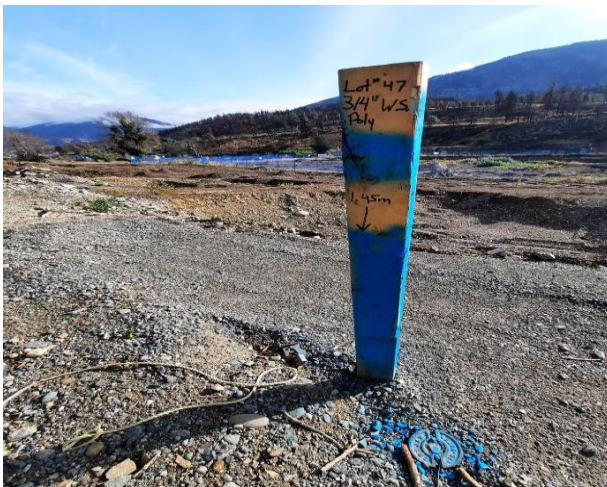
- Removal of metal and ACM debris from the footprint have now been completed at a total of 5 municipal properties and 140 private properties.
- Sewer and water capping have now been completed on a total of at 130 properties.
- Concrete footings have now been removed from a total of 85 properties.
- Contaminated soil has now been removed from a total of 55 properties.
-

Figure 7 – Capping of Sewer and Water infrastructure

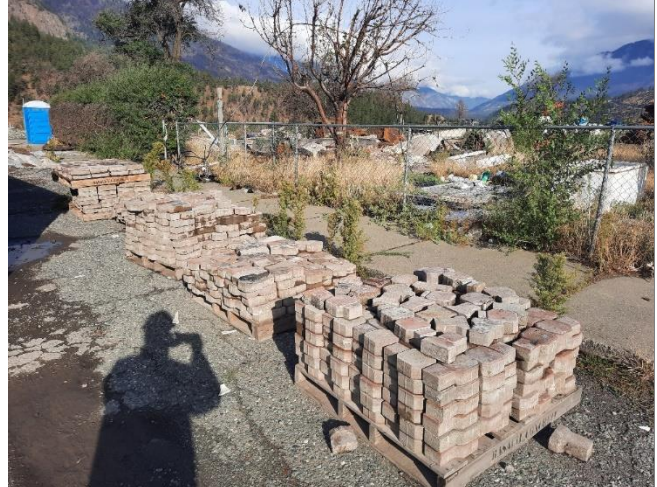
Figure 8 – Salvage bricks for re-use
