SEWER MASTER PLAN

Village of Lytton

March 18, 2022

Dan Mundall, P.Eng.

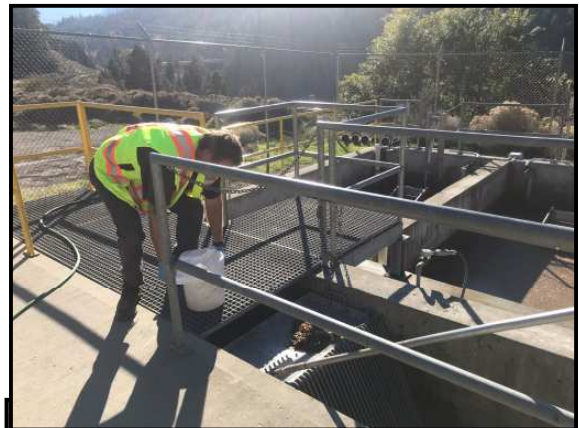
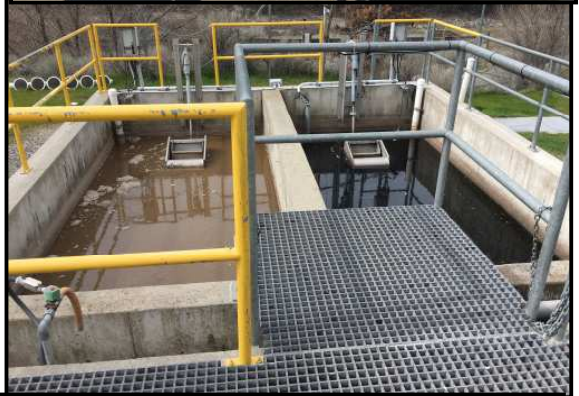
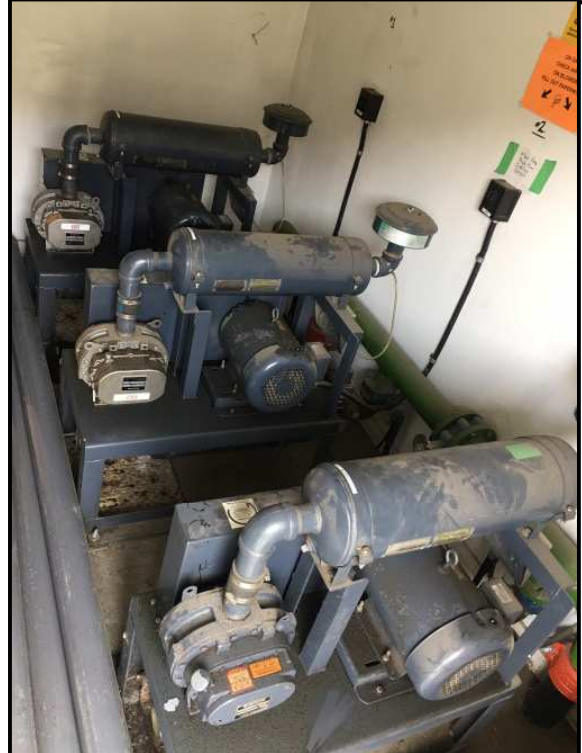
- **Preliminary Treatment:** Manually cleaned bar screen removing solids > 25mm (1")|. See photo →
- **Primary Treatment:** Sedimentation, hydrovac grit removal from SBR and recycle to aerated sludge reactor.
- **Secondary Treatment:** 2 SBR tanks, aerated sludge reactor, UV disinfection of plant discharge. See photo →
- **Sludge drying bed**
Outdoor earthen drying bed is scraped and emptied to landfill as needed.
- **Compressor Room (see photo below right) →**
Two compressors feed air to Reactor #1,2 and the third compressor provides air to the sludge reactor.

1. Preliminary automatic screening treatment – automatic mechanical bar screen with 6mm (1/4”) openings to replace manually cleaned bar screen with 25mm (1”) openings and thus limit the chance of solids causing disruption of the plant.
2. SCADA development systems for remote monitoring and control of plant. Includes backup battery power
3. Screened Solids (grit) management
4. Facultative Stabilization lagoons 2100 sq-m x 2.4m deep with circulation and on-demand aeration.
5. Standby Generator backup power for the plant
6. Odor Control system
7. Grit Removal system
8. SBR Reactors #3,4 or other improved secondary treatment as may be required in the future.

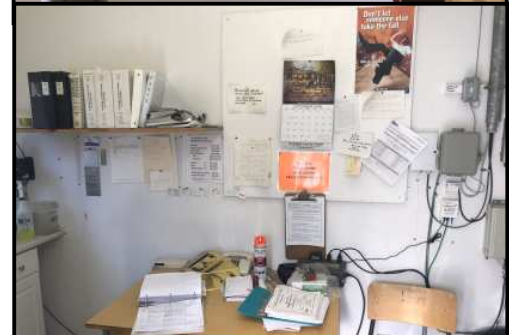
The plant is visited at least once per day for about 2 hours to perform routine inspection and maintenance tasks and record operational information. The facility also contains a lab sink and restroom and is ample for the needs it serves. (photo →)

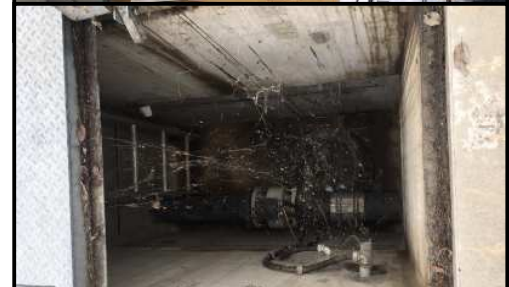
Flow leaving the plant is directed through a 150mm (6") mag type meter with totalizer capacity. Records are manually logged by the operator. (photo →)

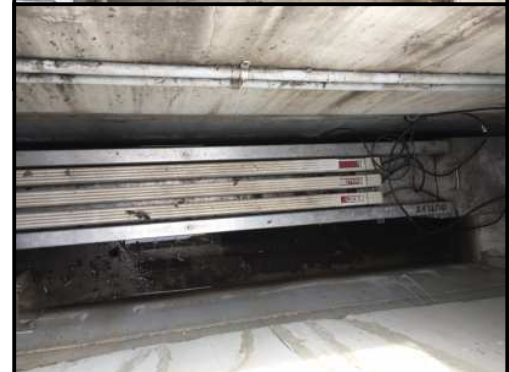
A UV treatment reactor is located just downstream from the mag flow meter (see photo below Right →). Records of lamp performance are logged by the operator.
